Environmental Studies for Route 234 at Brentsville Road Interchange

Prince William County
FHWA 1994 Final SEIS Number: FHWA-VA-EIS-79-03-FS
Submitted pursuant to 42 USC 4332(2)(c) and 23 CFR 771.130(c)

March 11, 2021

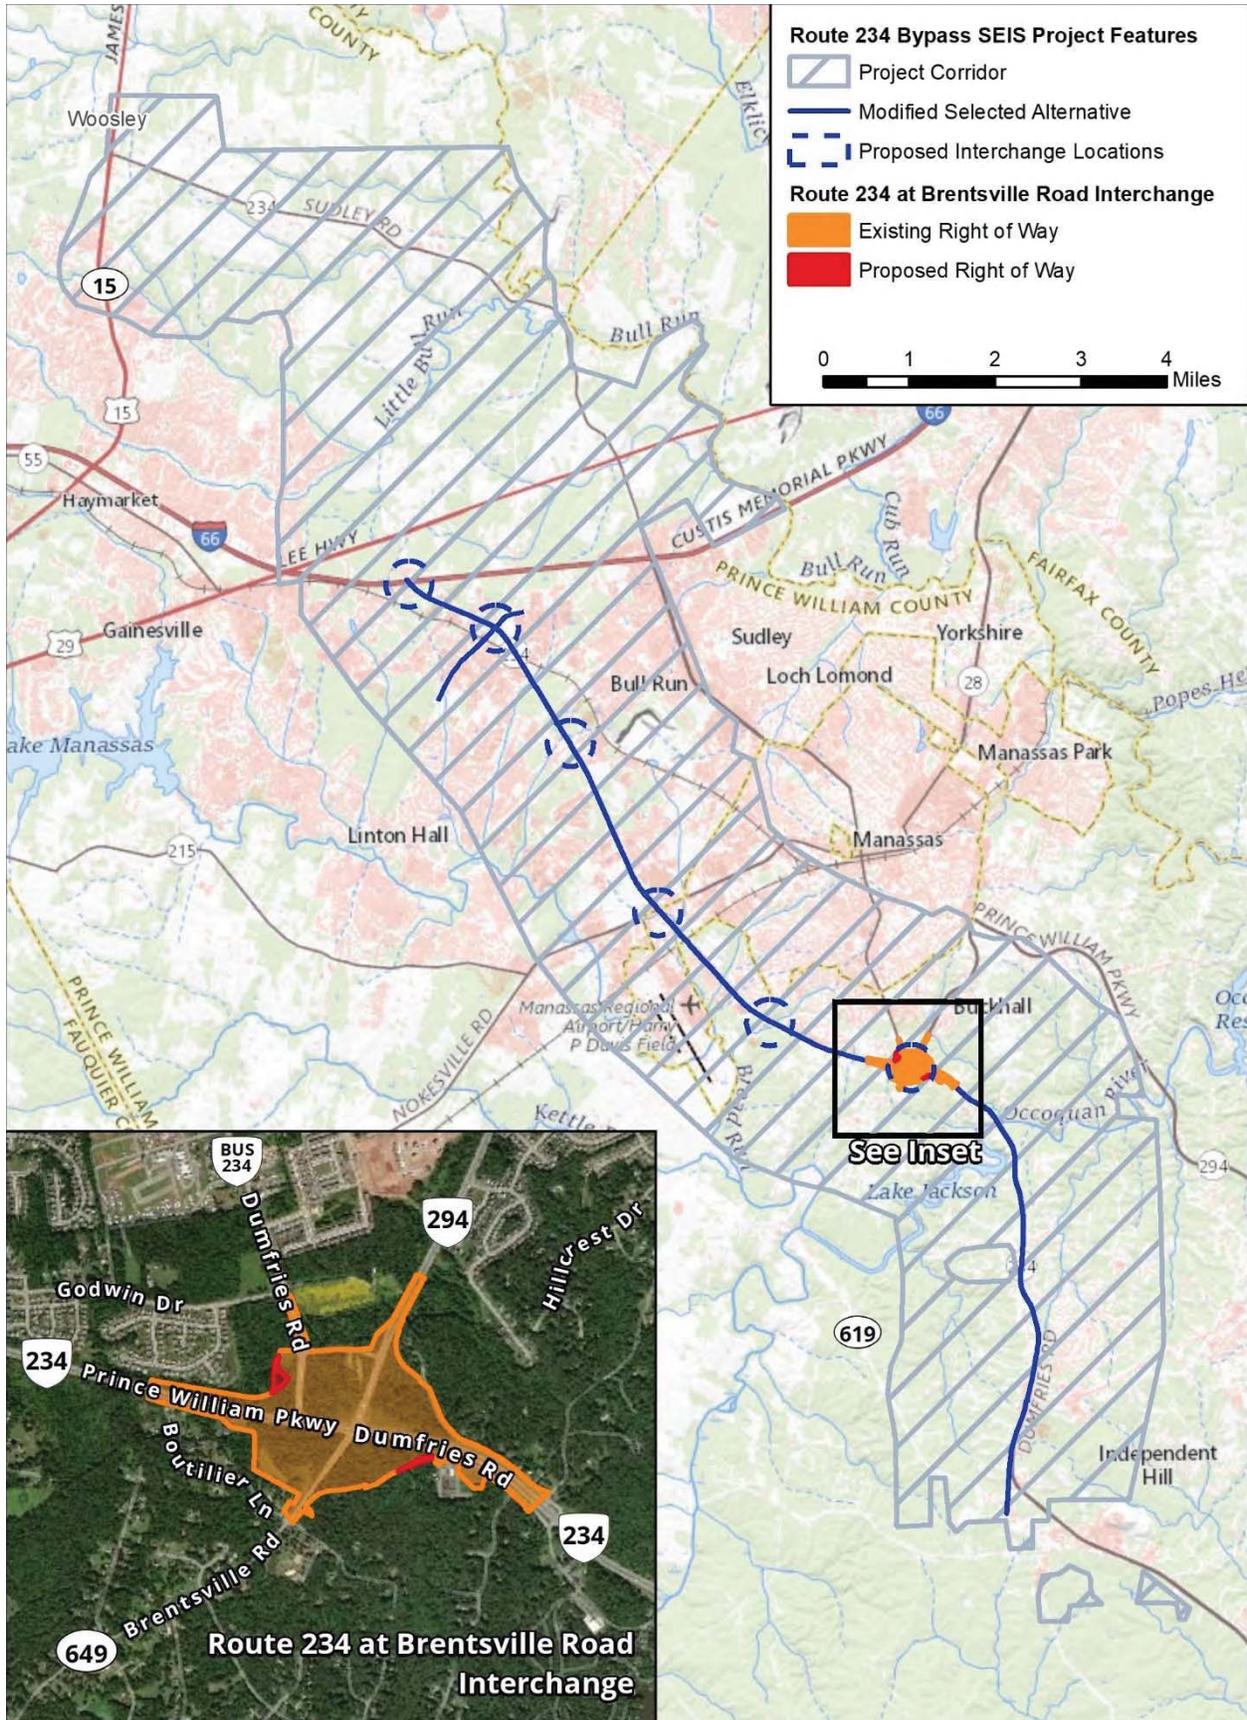
Figure 1. Route 234 Bypass SEIS Corridor and Route 234 at Brentsville Road Interchange Project Location

As shown in Figure 1, the location of the proposed improvements is essentially the same as was proposed and evaluated in the 1994 SEIS. Modifications have been made, however, to the design of the Prince William Parkway/Dumfries Road/Brentsville Road interchange to improve traffic operations.

The location of the proposed Route 234/Dumfries Road/Brentsville Road interchange is consistent with the location of the proposed facilities as presented in the SEIS (see Figure 1). The conceptual design addressed in the SEIS is depicted in **Figure 4**, which is an excerpt from Figure VIII-5 in the SEIS. As noted earlier, due to funding constraints, the junctions of Route 234, the Route 234 Bypass, the Prince William Parkway (Route 294), and Brentsville Road were built as signalized at-grade intersections. However, most of the right-of-way needed to accommodate the interchange was acquired during the original Route 234 Bypass implementation.

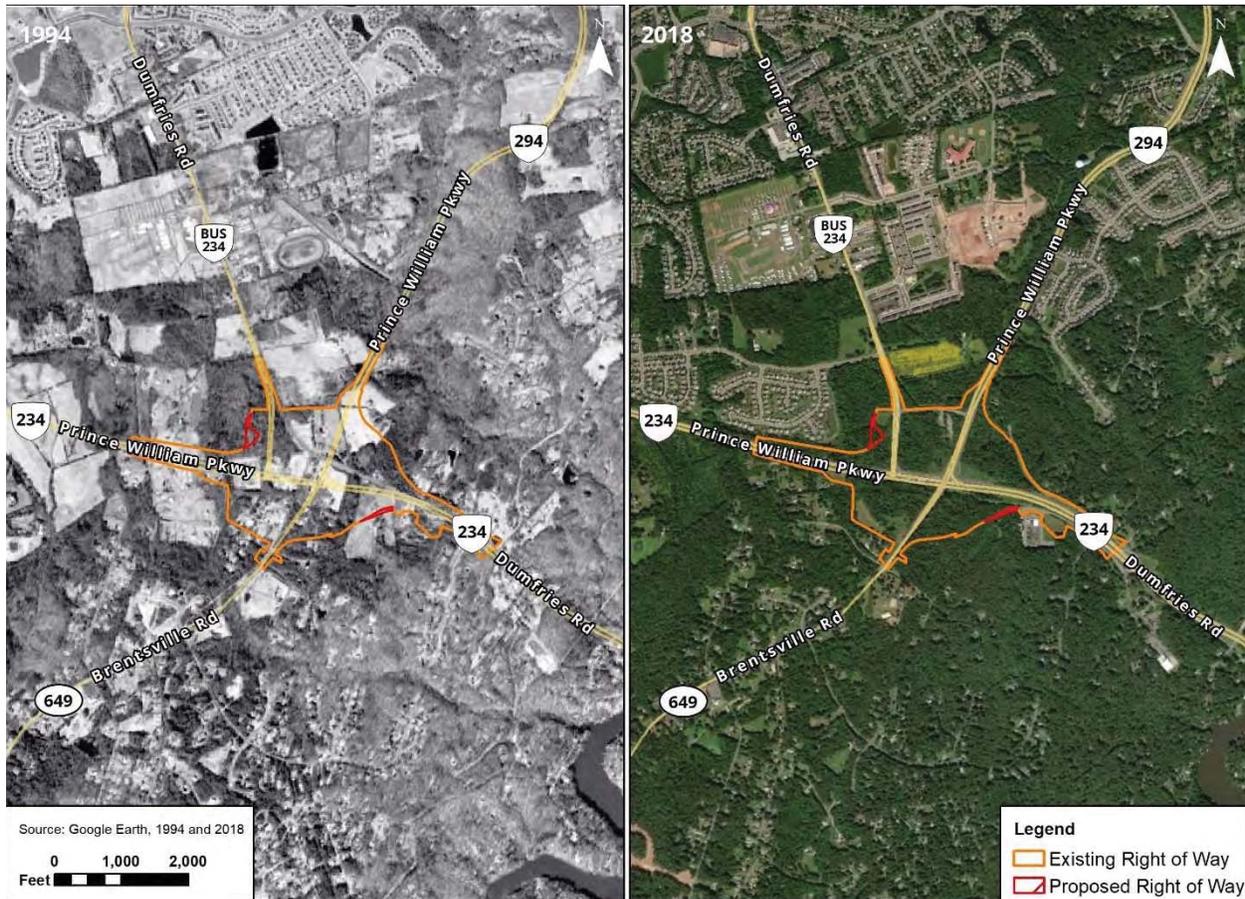
Figure 2. Comparison of Land Cover in Project Area, 1994 (left) and 2018 (right)

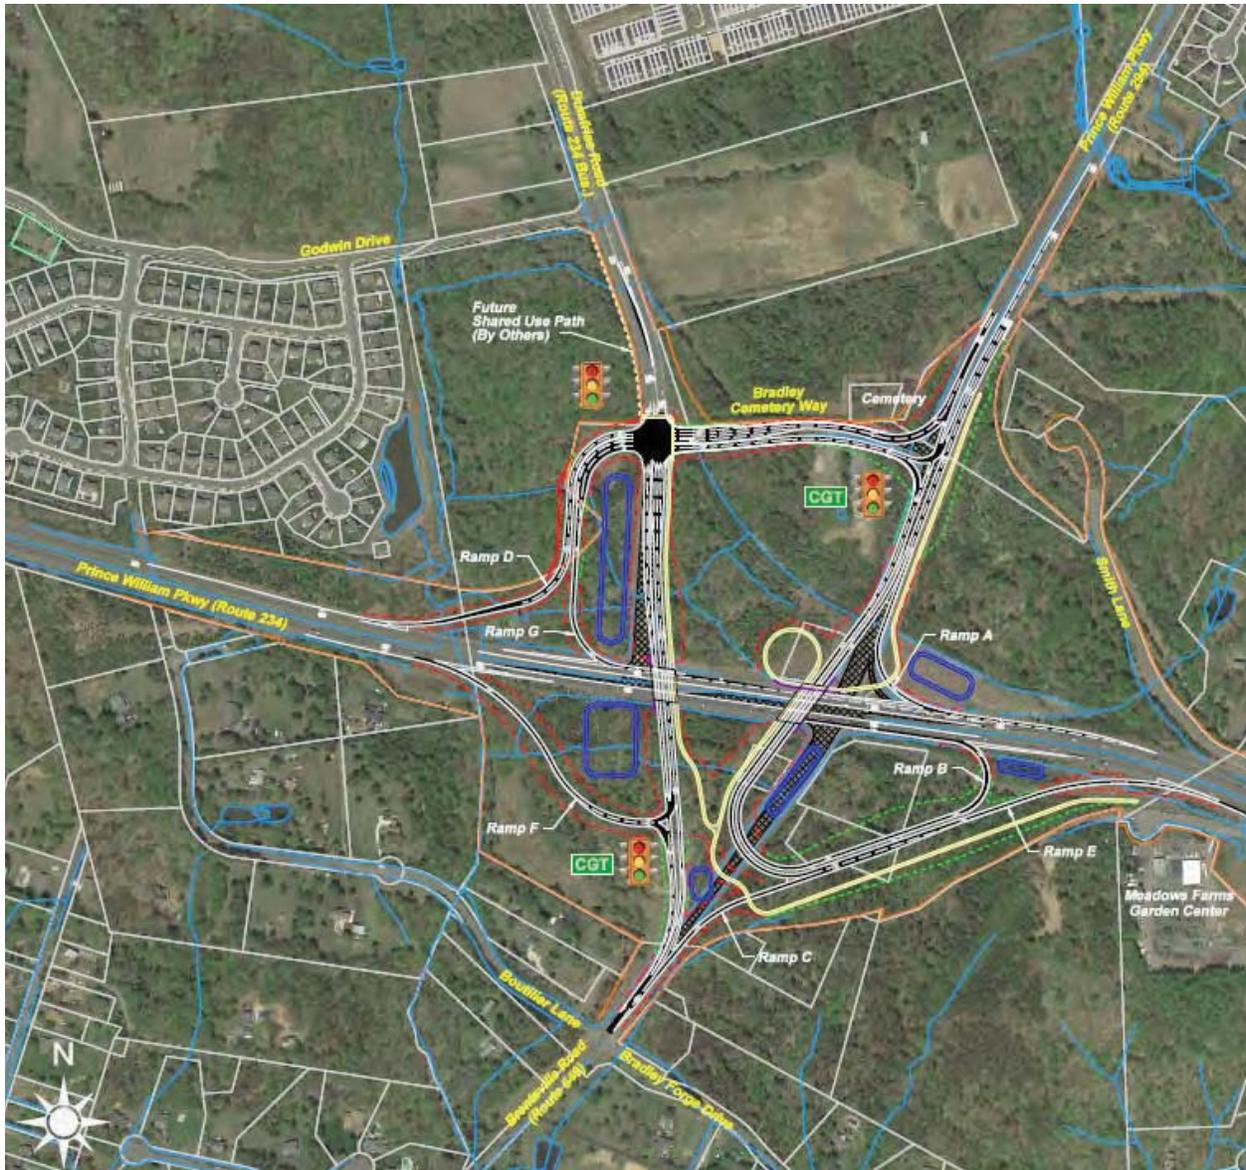
Figure 5. Proposed Brentsville Road Interchange

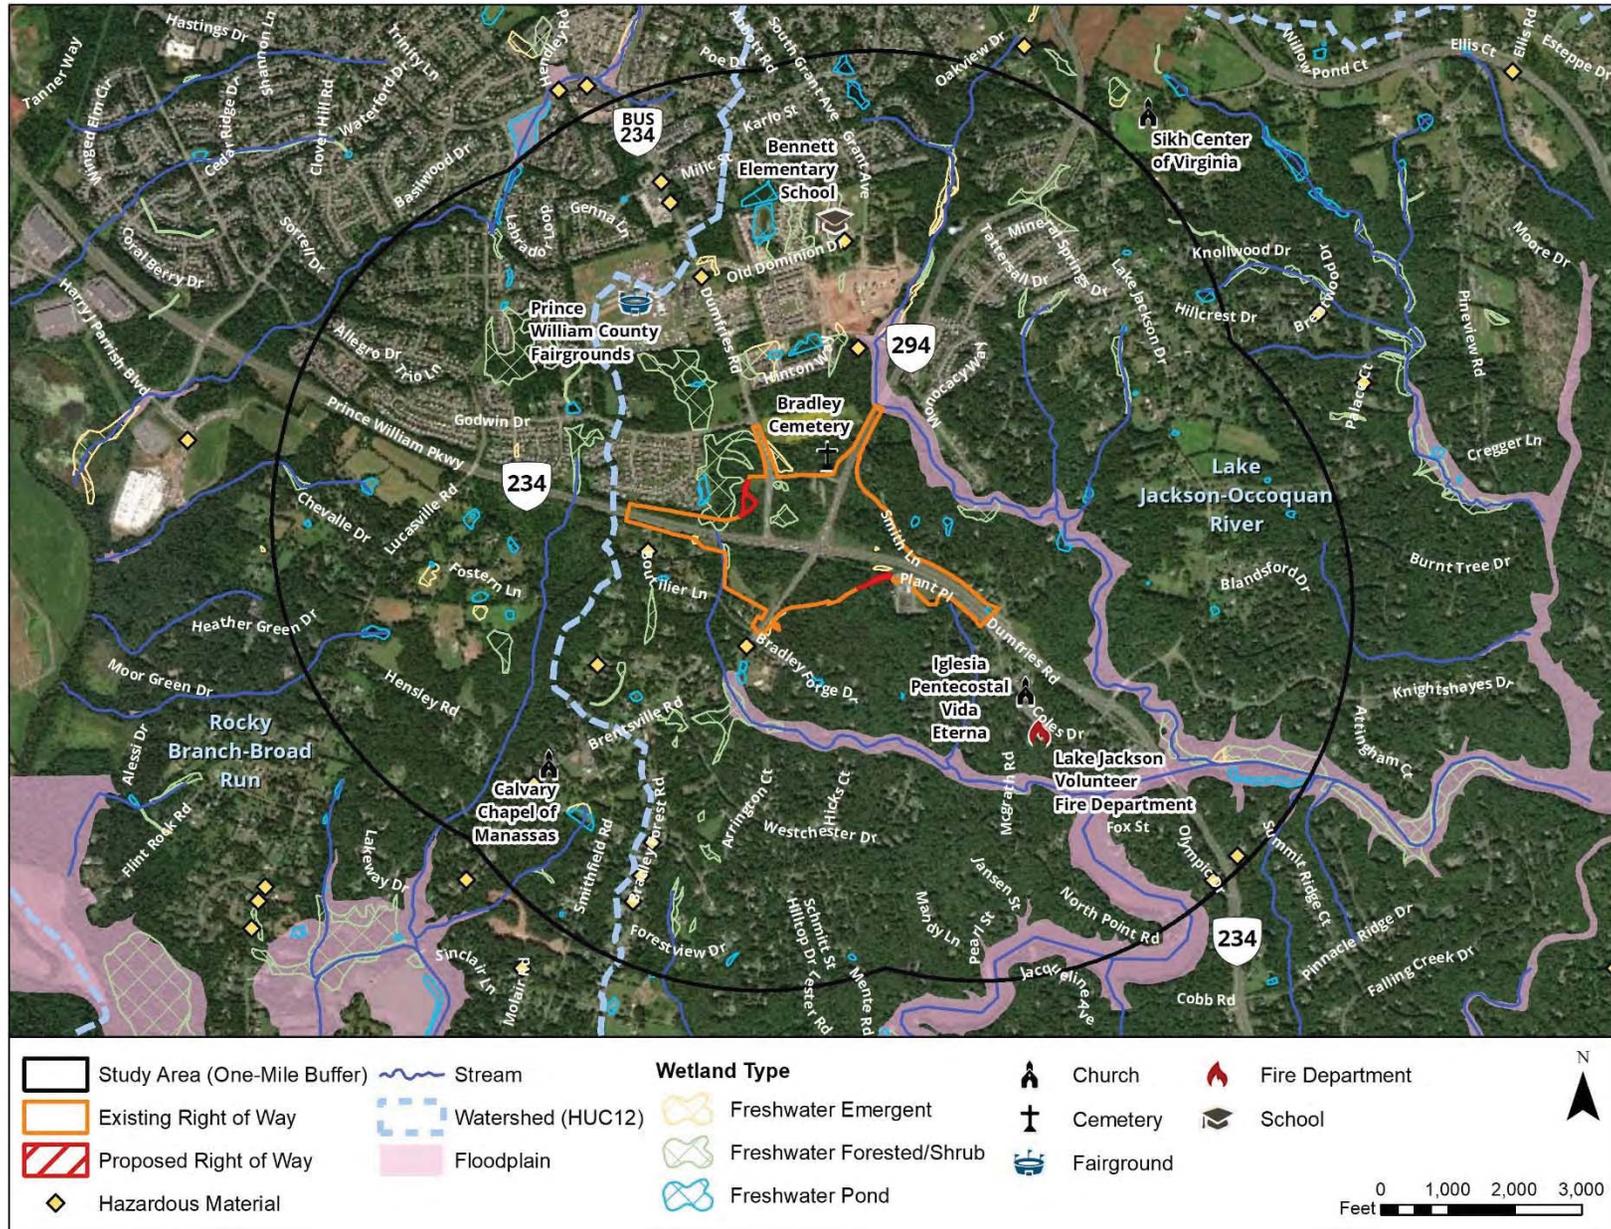
Figure 6 shows the LOD for the proposed improvements and environmental resources based on available geographic information systems (GIS) data and field reconnaissance. As indicated above, the current LOD consists of existing and proposed right-of-way and includes all of the areas encompassed by the proposed improvements. Resource impacts estimated in this Environmental Studies document are expected to decrease with further design and refinement of the LOD. **Table 1** summarizes the environmental studies conducted and documents the changes that have occurred in the project and its impacts within the current regulatory context. **Table 2** quantifies and compares impacts reported in the vicinity of the Dumfries Road/Brentsville Road interchange as presented in the SEIS with updated values for the current interchange conceptual design. A list of anticipated regulatory permits and authorizations for the project is provided in **Table 3**.

Figure 6. Environmental Resources within One Mile of the Project Area

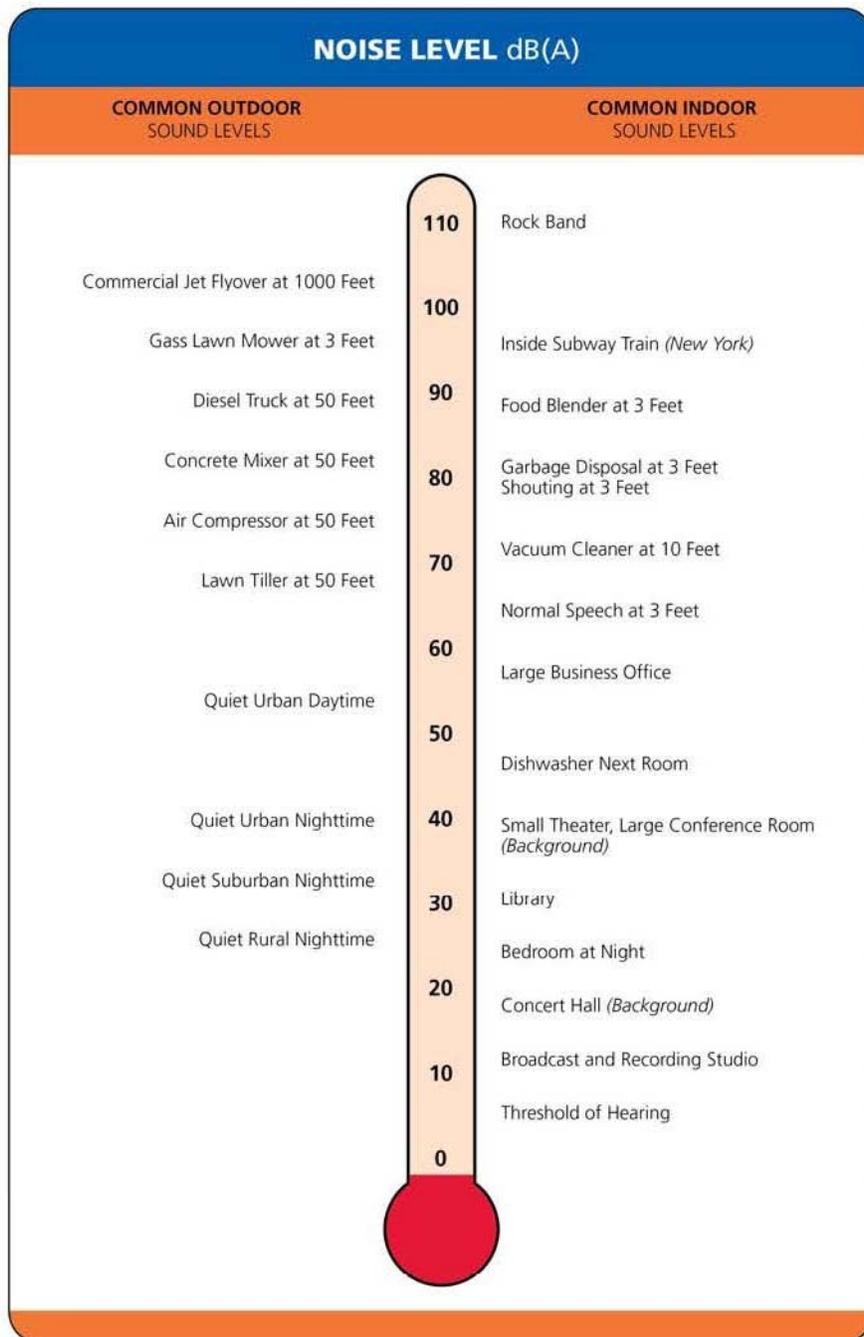
Figure 2-1. Typical A-Weighted Noise Levels

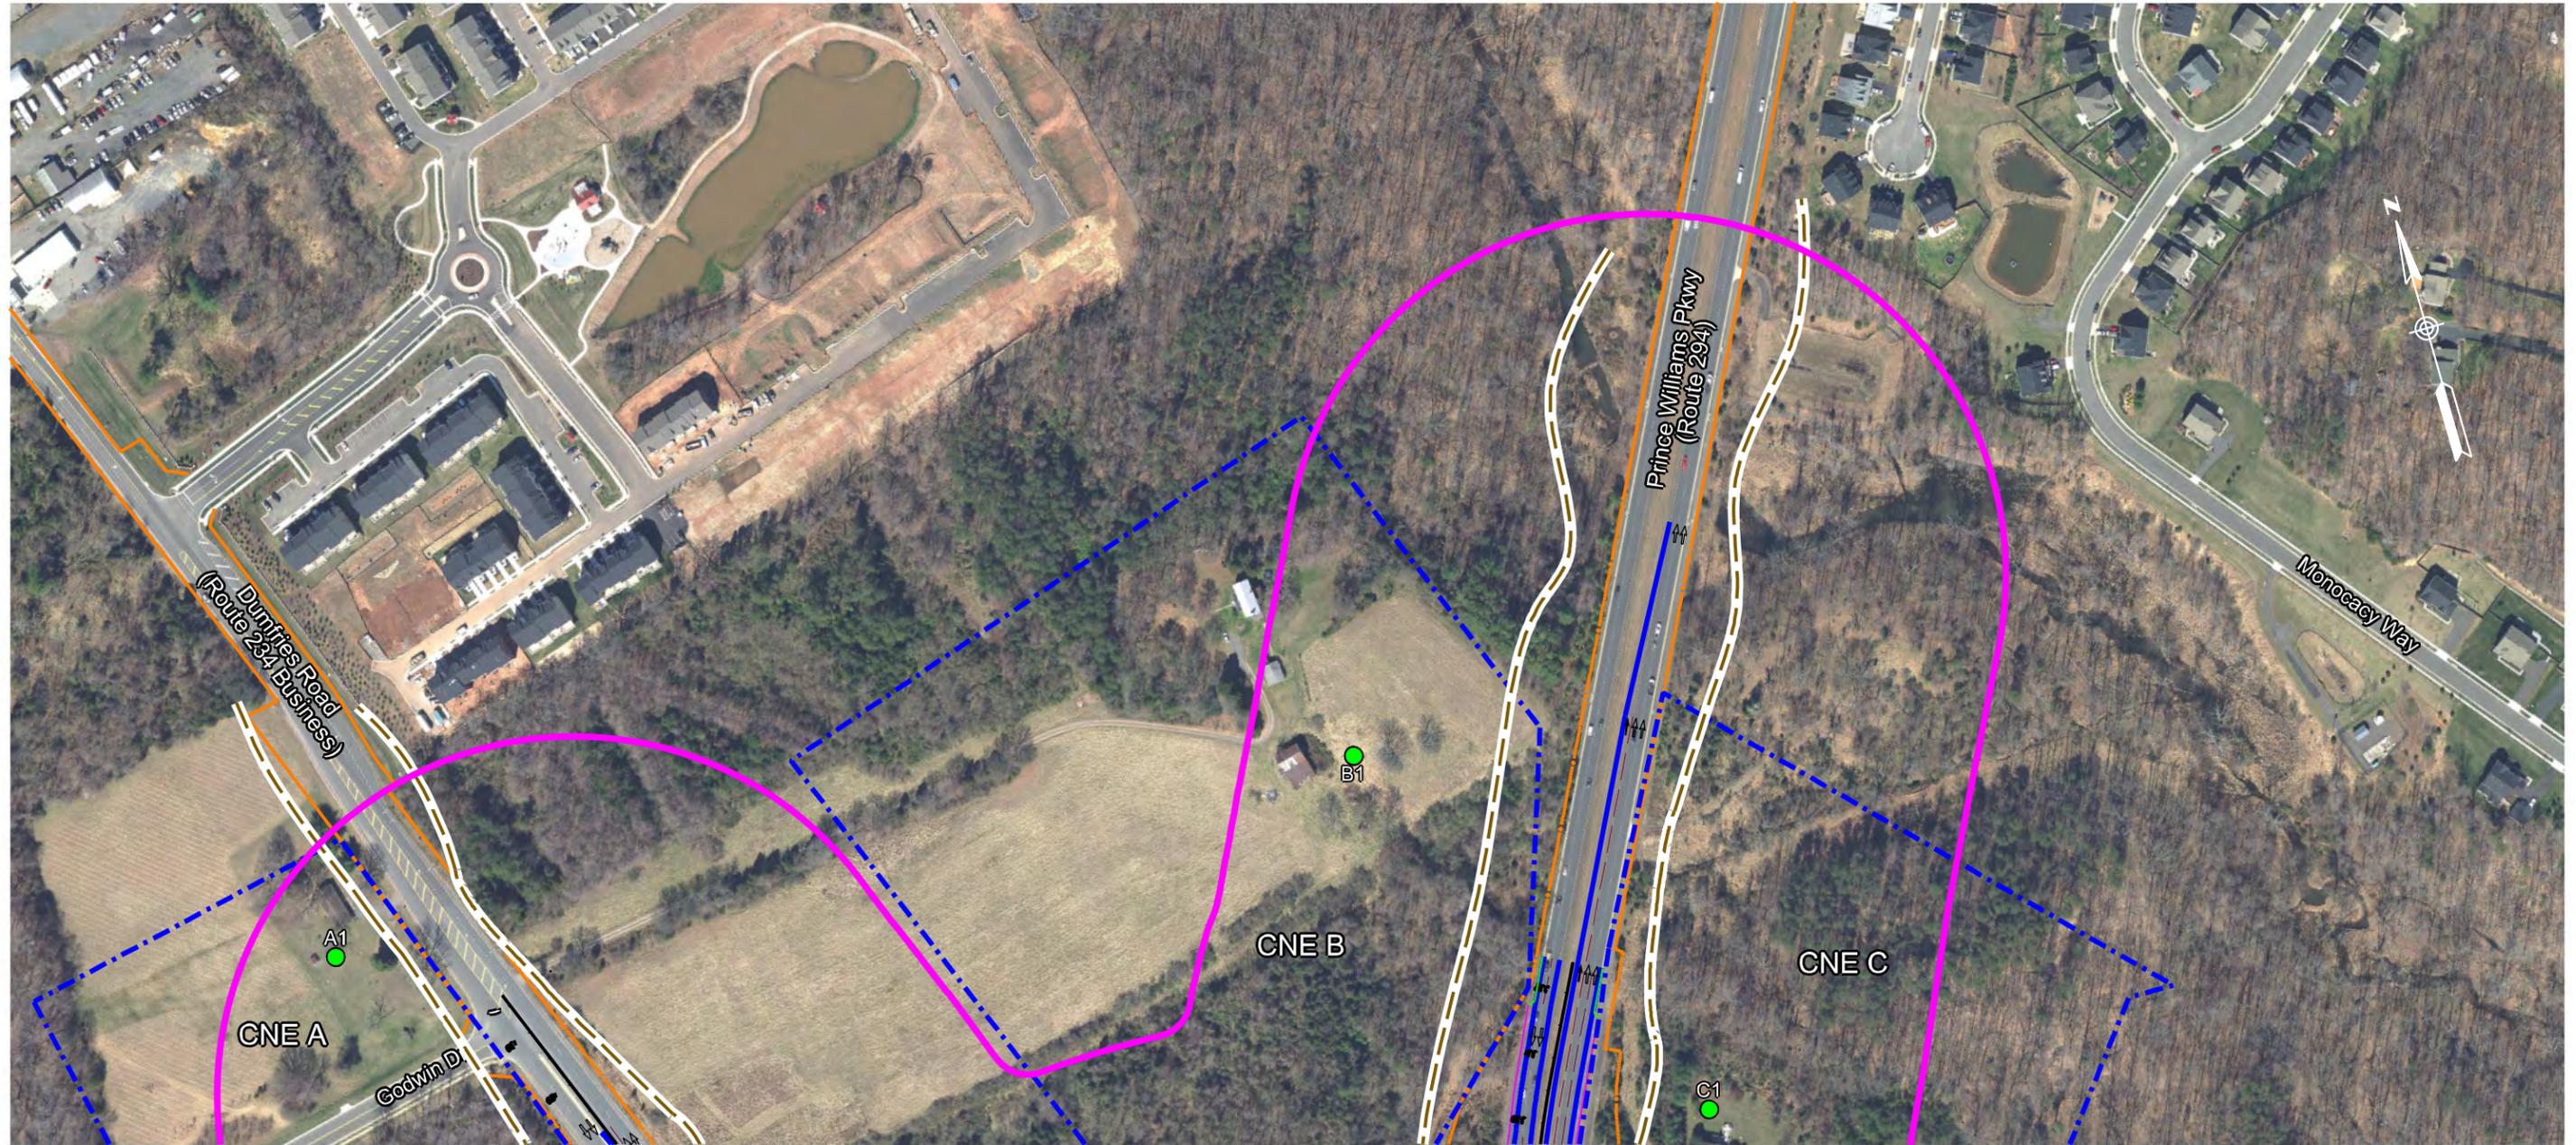
Figure 1
Noise Prediction
Locations and Potential
Noise Barriers

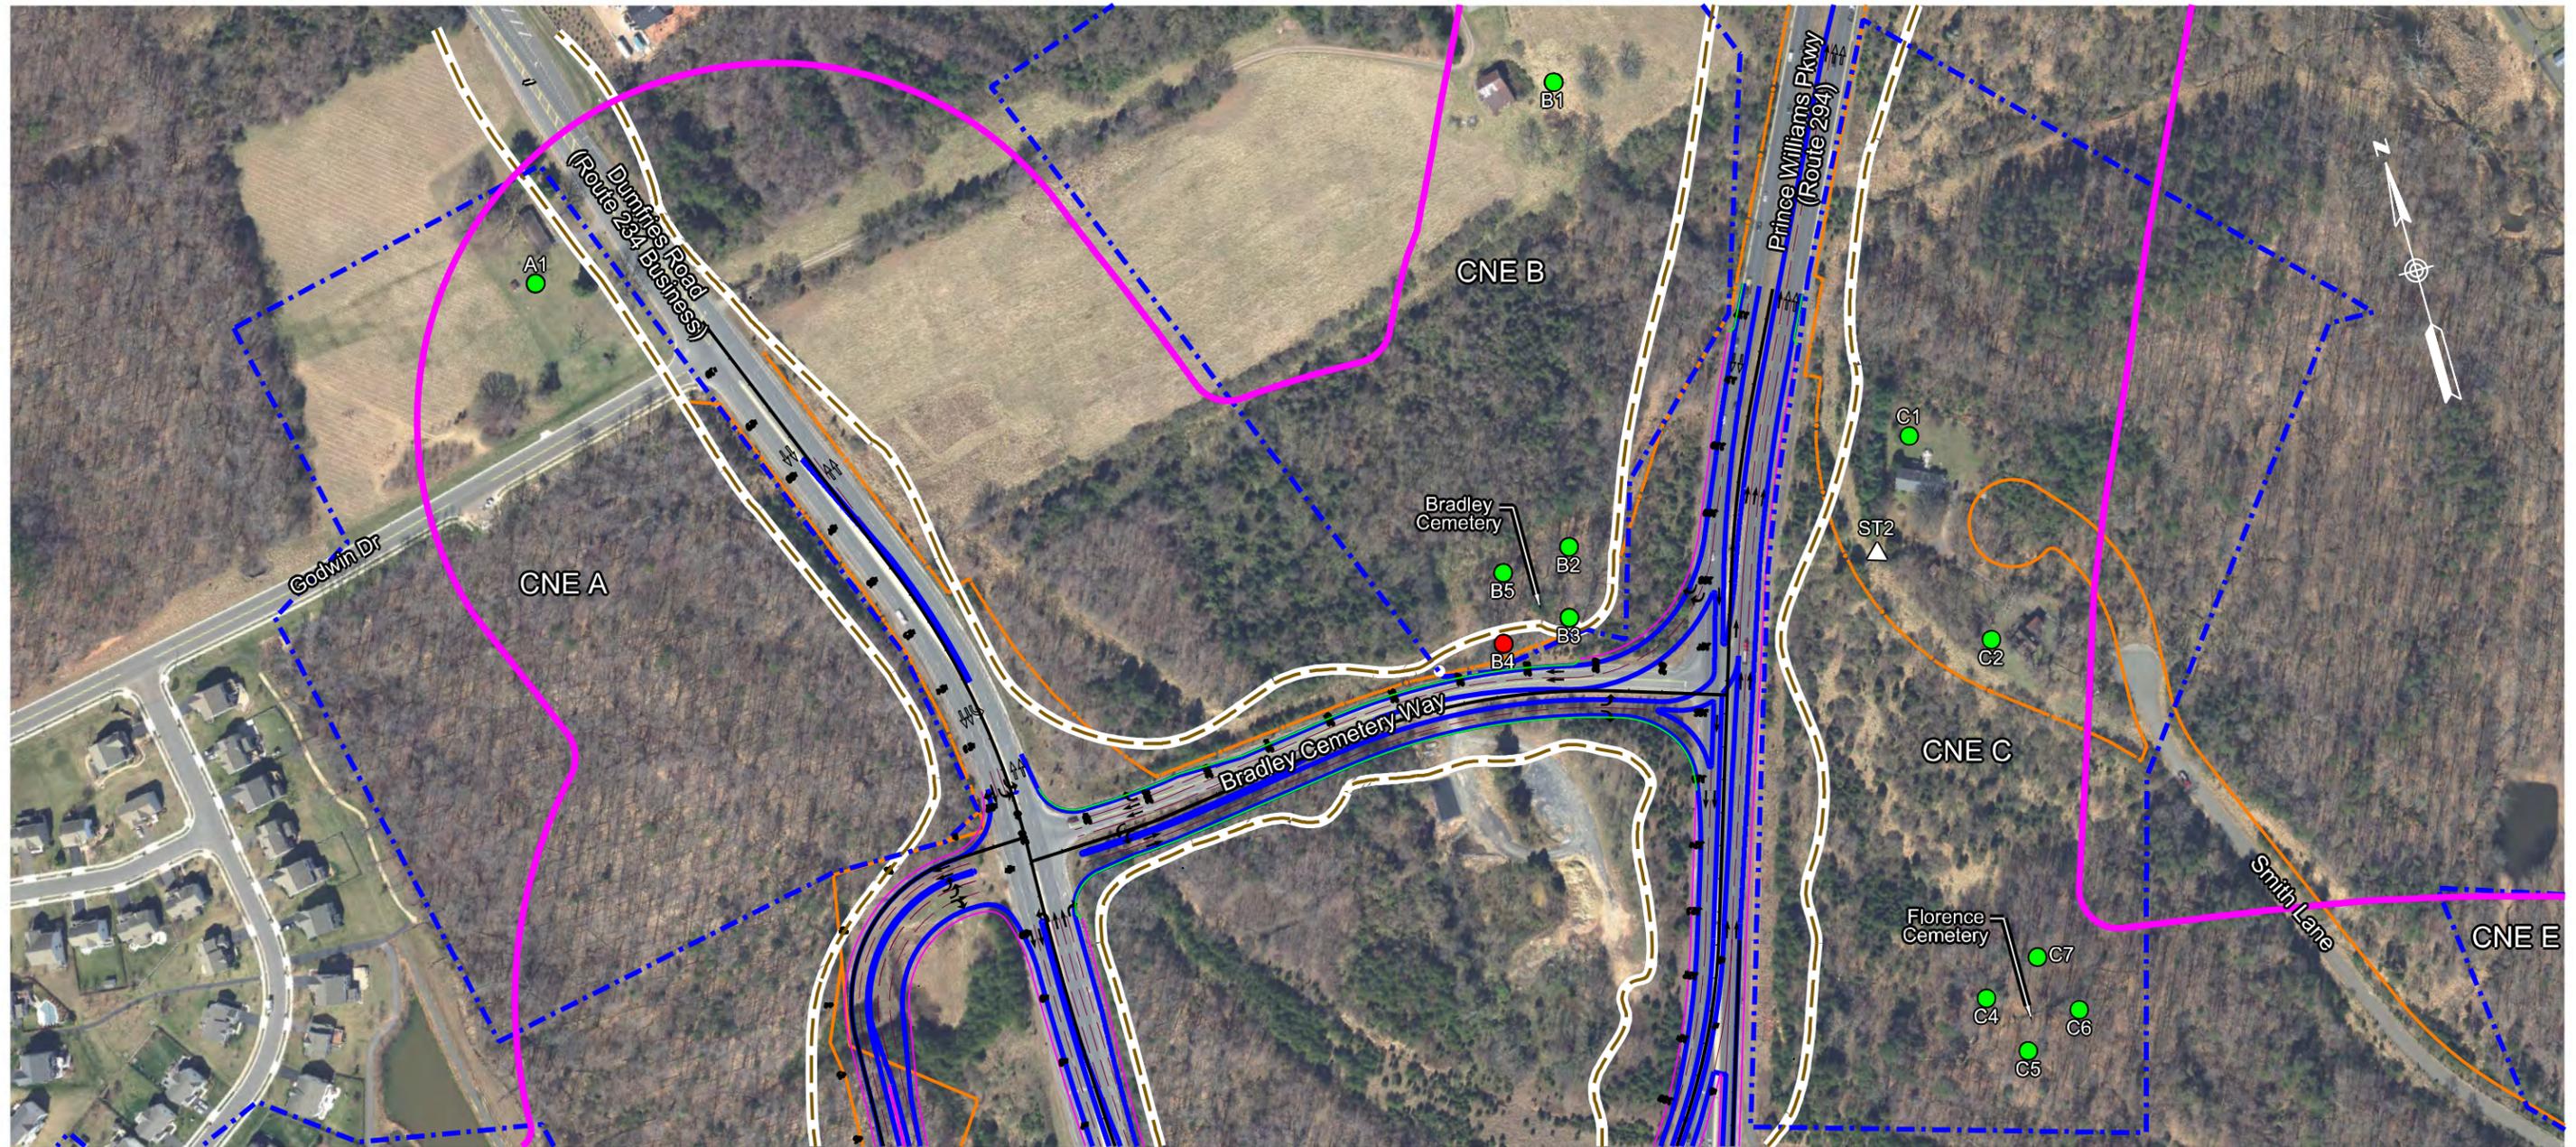
Figure 2
Noise Prediction
Locations and Potential
Noise Barriers

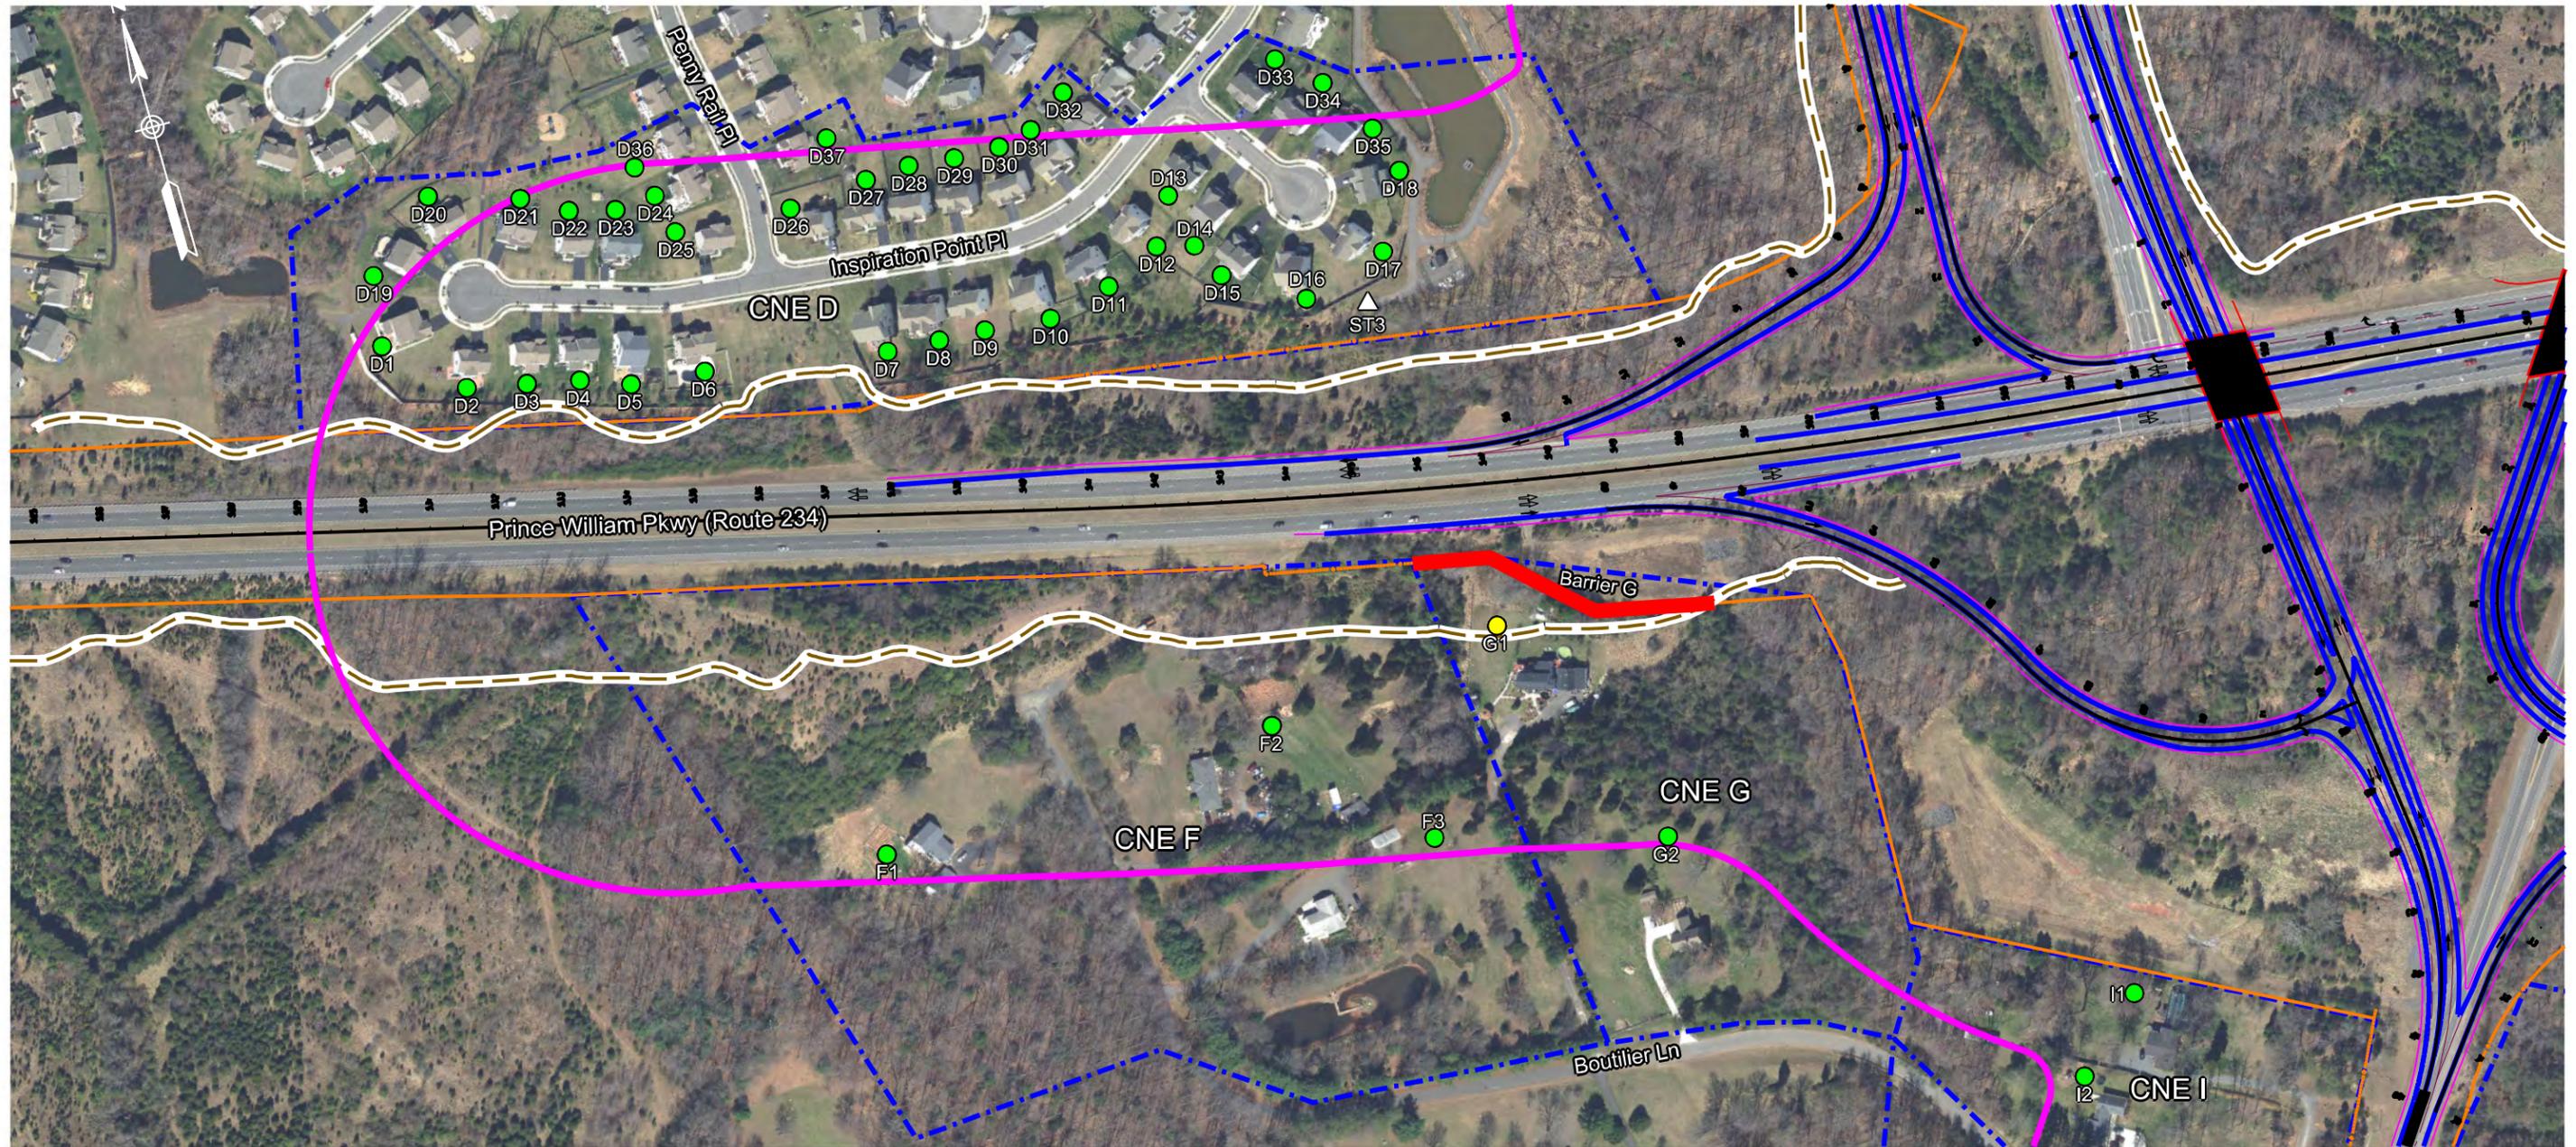
Figure 3
Noise Prediction
Locations and Potential
Noise Barriers

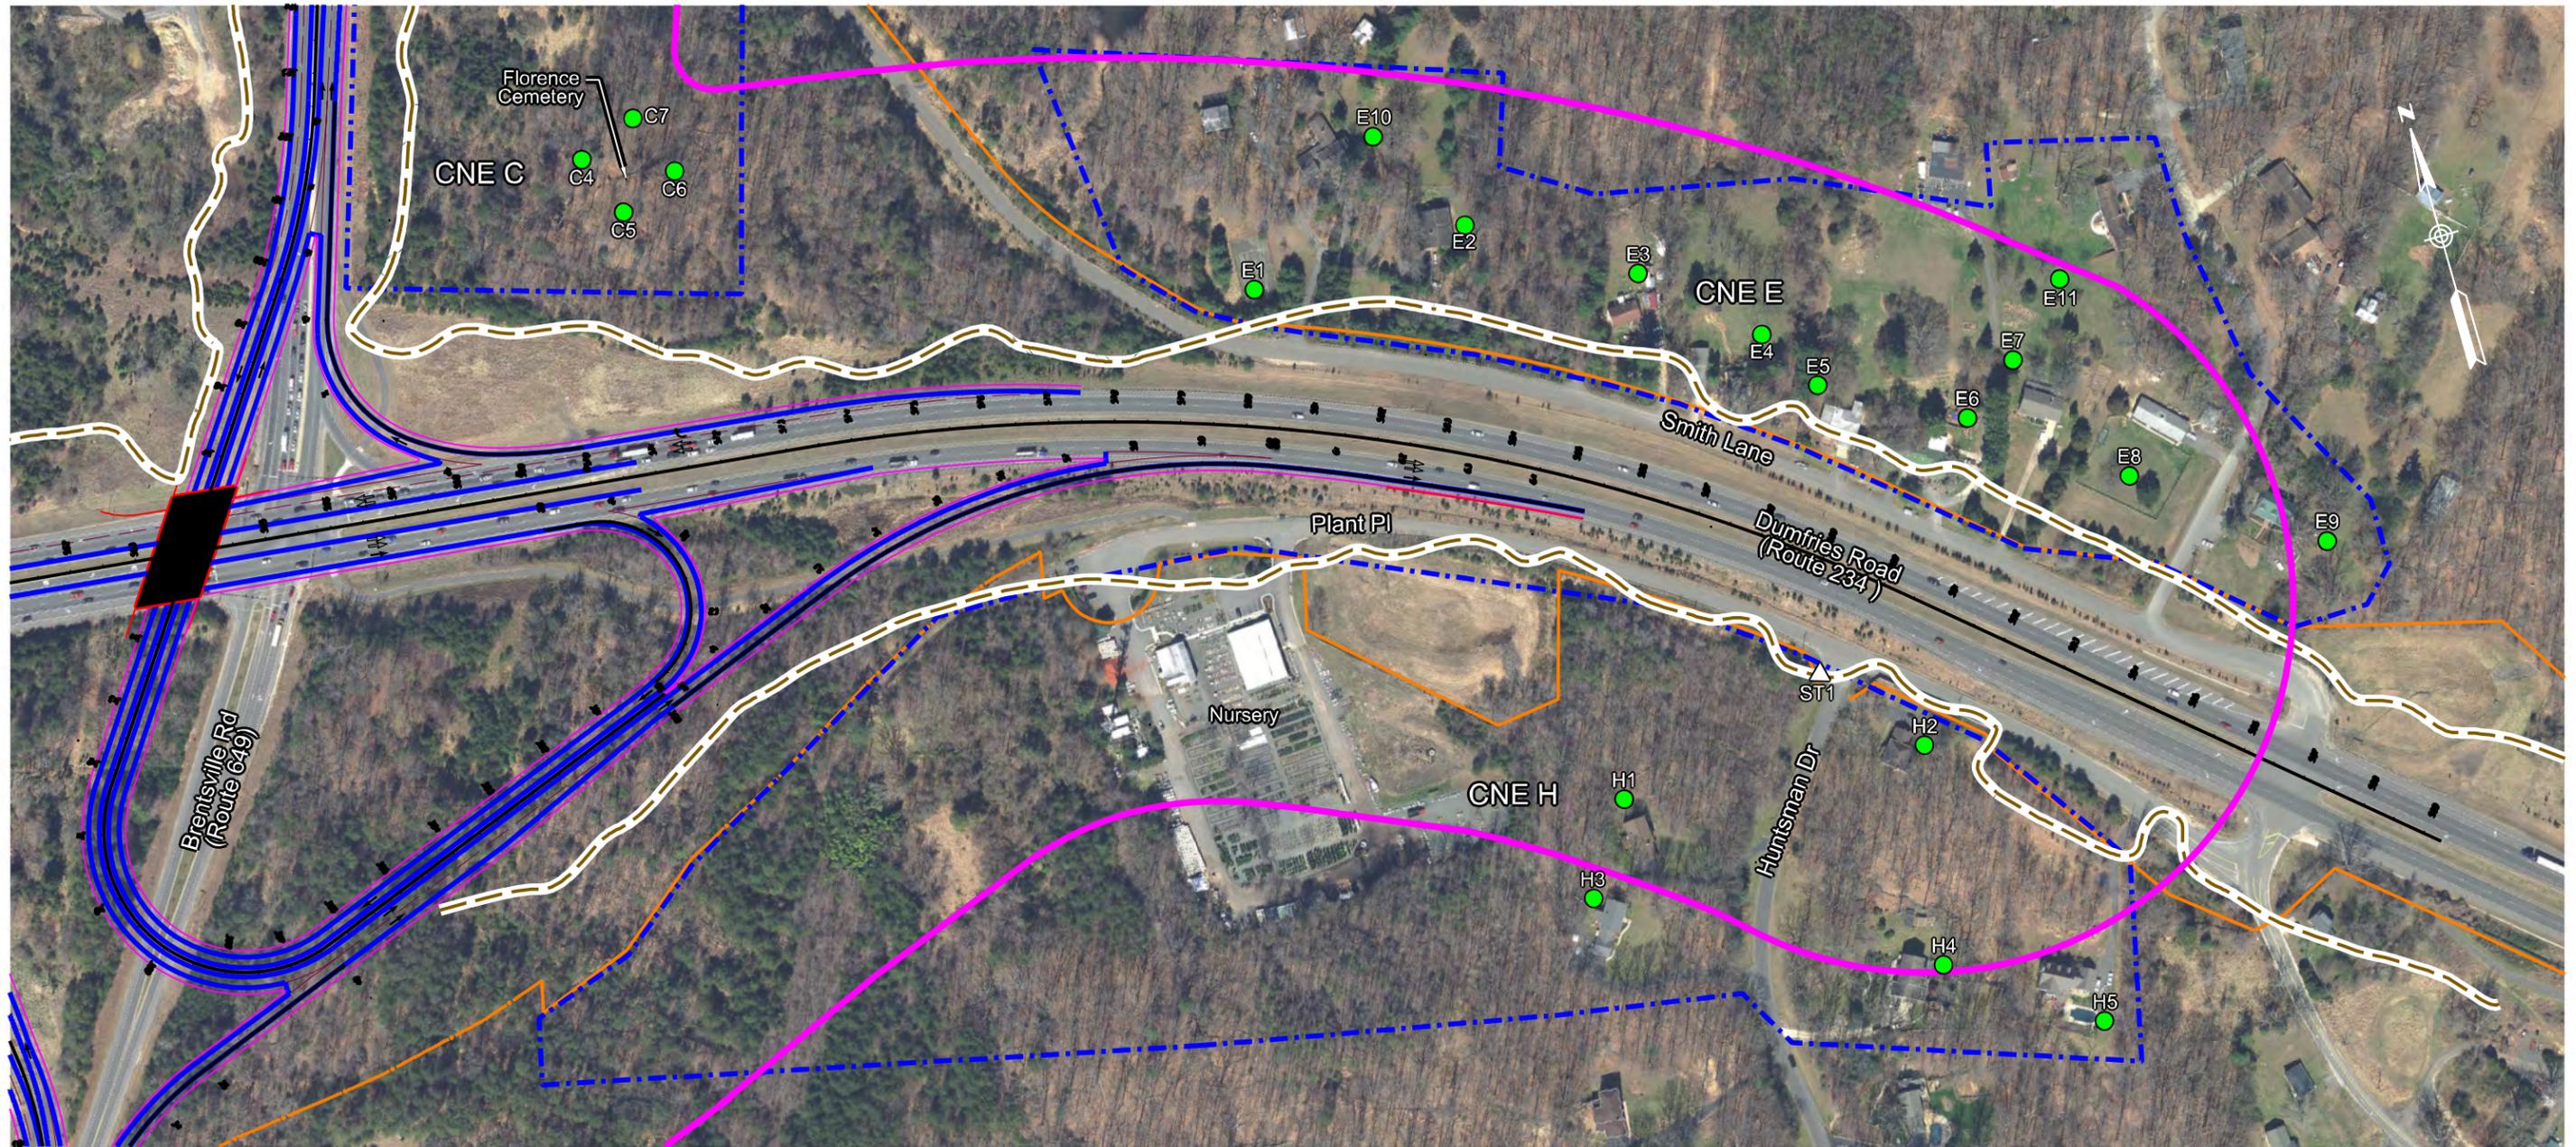
Figure 4
Noise Prediction
Locations and Potential
Noise Barriers

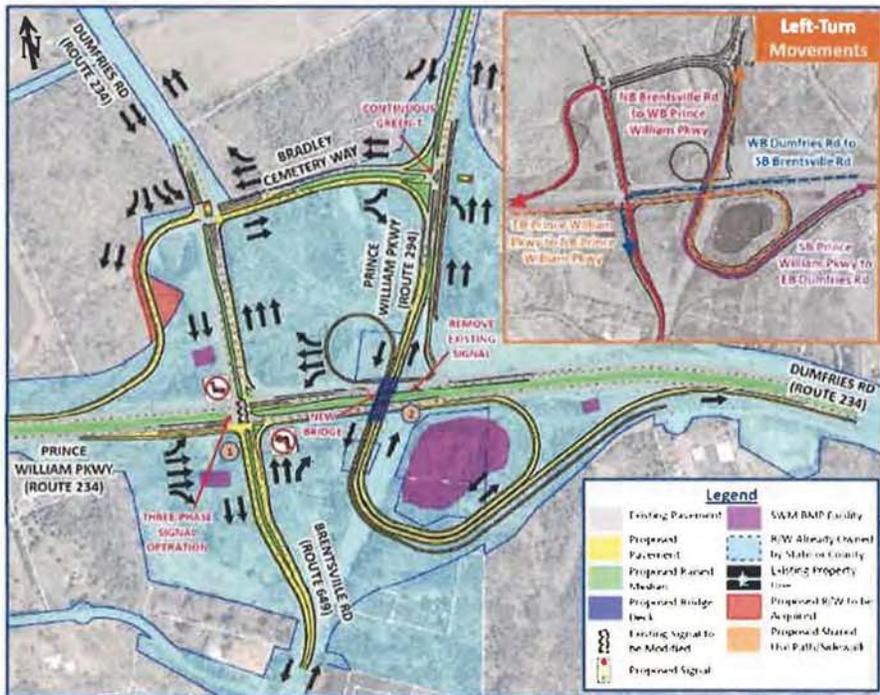
Figure 1. Working Concept Design for Proposed Brentsville Road Interchange
